**Flood Control Project Maintenance  
Levee Inspections**

**Fall 2018 Levee Maintenance Deficiency Summary Report**

**Flood Control Project Maintenance  
Levee Inspections****LMA District Cover Sheet****Fall 2018 Levee Inspection Results****Yolo County Department of Natural Resources**

Waterway			Bank	Unit Miles
Unit No. 01 Right Bank Cache Creek			Right	0.59
	Spring (March - May)	Summer (June - August)	(September - November) Fall	Winter (December - February)
Unit Maintenance Rating (Fall Only)			<b>U</b>	
Date of Inspection	3/7/2018 - 3/7/2018		9/28/2018 - 9/28/2018	
DWR Inspector	Zach Jojola		Zach Jojola	
Accompanied By	Casey Leibler o County Department of Natural Resources		Casey Leibler o County Department of Natural Resources	
			Thomas Engler MBK

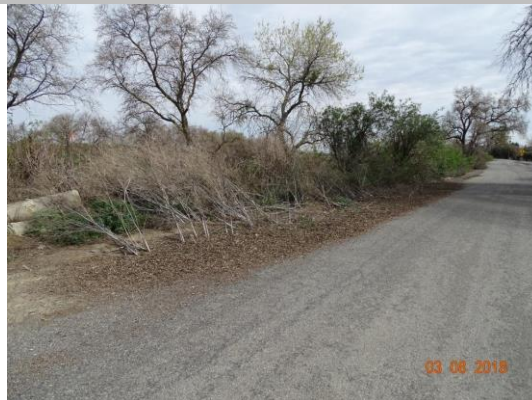
Photo 1 of 2 : FA\_2018\_NA0021\_351\_23\_20180904\_00017.jpg

LM Start	0.03	Rating **	U	Issue No.	23
LM End	0.07	Issue Type +	Ma	Location *	WS
Category	Earthen Levee			GPS Latitude/Longitude	
				Start	End
Item	Vegetation			38.720892 °	38.721020 °
				-121.810421 °	-121.809792 °
DWR ID	DWR_NA0021_01_s_2017_23				
Comment Code					
V2 : Remove the wild growth other than native grasses from the levee slopes.					
Inspector Comment					
Thick vegetation on waterside slope.

Wild vegetation on the waterside levee slope, blocking visibility. Spring 2018.

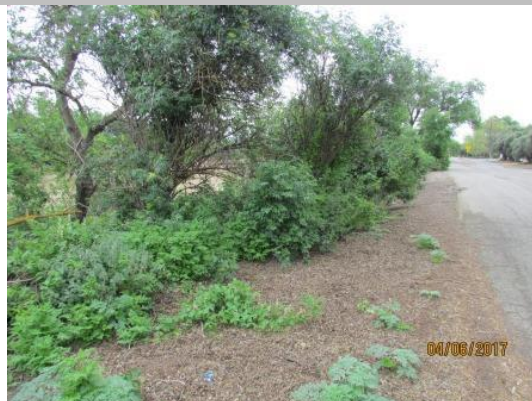
Photo 2 of 2 : FA\_2018\_NA0021\_351\_23\_20180904\_00018.jpg

Wild vegetation on waterside levee slope, blocking visibility. Spring 2017.

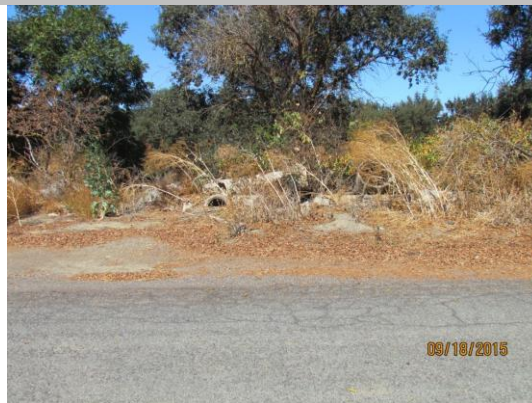
Photo 1 of 1 : FA\_2018\_NA0021\_351\_15\_20180904\_00008.jpg

LM Start	0.03	Rating **	M	Issue No.	15
LM End	0.03	Issue Type +	Ma	Location *	WS
Category	Earthen Levee			GPS Latitude/Longitude	
				Start	End
Item	Encroachments			38.720895 °	38.720895 °
				-121.810408 °	-121.810408 °
DWR ID	DWR_NA0021_01_f_2015_15				
Comment Code					
DE : Debris					
Inspector Comment					
Concrete pipes on waterside slope.

View of the debris on the waterward side of the levee. Fall 2015.

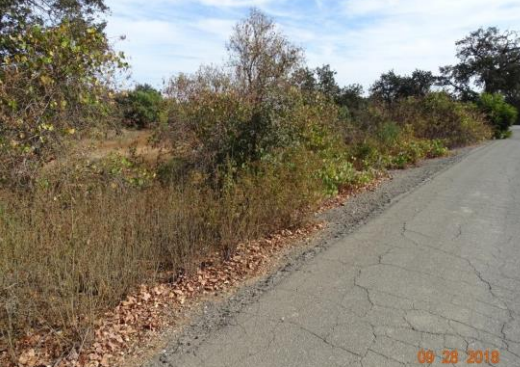
Photo 1 of 1 : FA\_2018\_NA0021\_351\_6\_20181001\_00022.jpg

View of the vegetation on the waterside slope. Fall 2018.

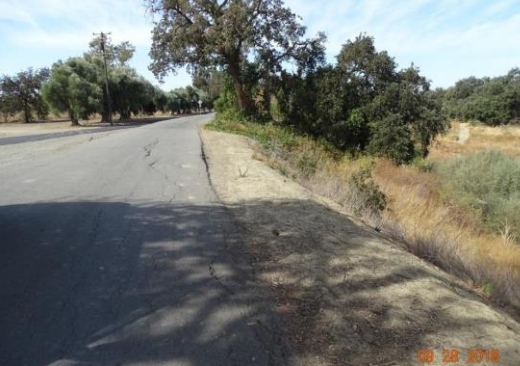
Photo 1 of 1 : FA\_2018\_NA0021\_351\_9\_20181001\_00023.jpg

View of the longitudinal cracking on the crown and waterside slope. Fall 2018.

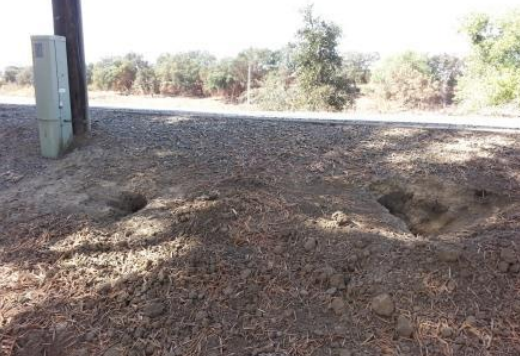
Photo 1 of 3 : FA\_2018\_NA0021\_351\_16\_20180904\_00009.jpg

An updated view of rodent holes on LS slope. Fall inspection 10/07/2016

LM Start	0.19	Rating **	U	Issue No.	16 (cont)	
LM End	0.19	Issue Type +	Ma	Location *	LS	
Category	Earthen Levee			GPS Latitude/Longitude		
				Start		End
Item	Animal Control			38.721536 °		38.721536 °
				-121.807711 °		-121.807711 °
DWR ID	DWR_NA0021_01_s_2015_16					
Comment Code						
A3 : No rodents visible, but rodent burrows visible; need to backfill and compact or grout burrows.						
Inspector Comment

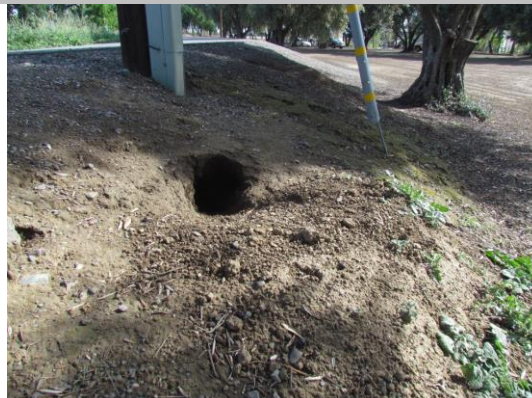
Photo 2 of 3 : FA\_2018\_NA0021\_351\_16\_20180904\_00010.jpg

View of the rodent hole on the landward side of the levee looking downstream. Spring 2015.

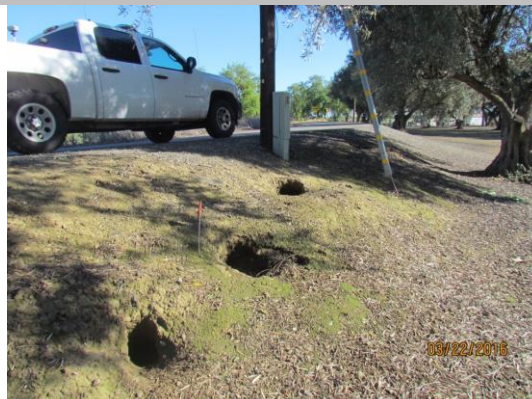
Photo 3 of 3 : FA\_2018\_NA0021\_351\_16\_20180904\_00011.jpg

View of the rodent holes on the landward side of the levee looking downstream. Spring 2016.

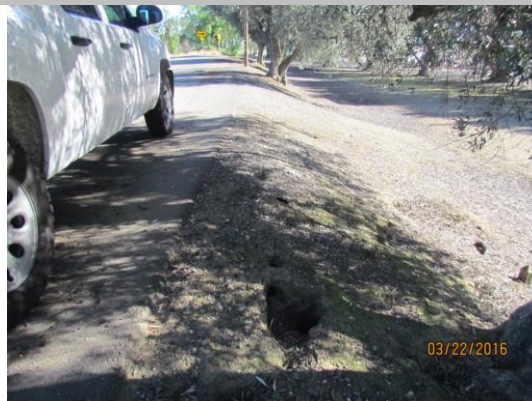
Photo 1 of 2 : FA\_2018\_NA0021\_351\_7\_20180904\_00005.jpg

LM Start	0.20	Rating **	M	Issue No.	7
LM End	0.20	Issue Type +	Ma	Location *	LS
Category	Earthen Levee			GPS Latitude/Longitude	
				Start	End
Item	Animal Control			38.721683 °	38.721683 °
				-121.807532 °	-121.807532 °
DWR ID	DWR_NA0021_01_s_2016_7				
Comment Code					
A3 : No rodents visible, but rodent burrows visible; need to backfill and compact or grout burrows.					
Inspector Comment

Perspective view of the rodent hole on the landward side of the levee looking downstream. Spring 2016.

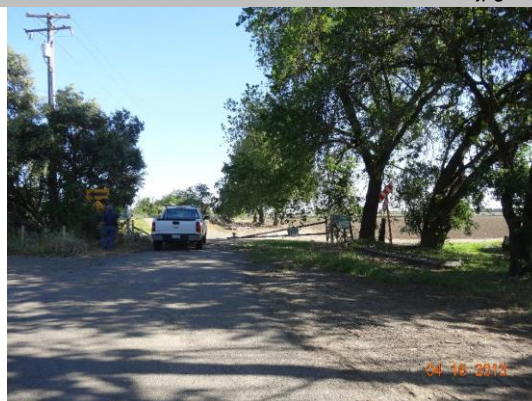
Photo 1 of 3 : UCIP\_FA\_2018\_39855\_69553.jpg

Comment Code						
Inspector Comment						
FS_ID:39855 DS_ID:19554 EP_NO: 6790 Repair Type: Non-Urgent Crossing Status: Indicator Found UCIP Comments: Need to contact owner to determine if crossing is still active and to determine last inspection date. Will need copy of letter showing crossings passed inspection. FIELD_STRUCT_DESC: 6-inch steel natural gas pipeline through the levee, 4 feet below the crown. Pipe extends from borrow area and under the channel. Bleeder valve on the waterside (WS) bank. Service vault located on the landside (LS) next to access gate. Paved access ramp on the LS slope. (Plans to lower a 6-inch high-pressure gas main crossing Cache Creek authorized under Permit No. 6790, 1969 - Pacific Gas and Electric Company [PG&E]). [Additional Reference(s): DWR Levee Log, 2004]. FS Date: 4/16/2013

View of landward side near access gate. Gas line marker located on between trees. Line runs parallel to access roadway and through levee.

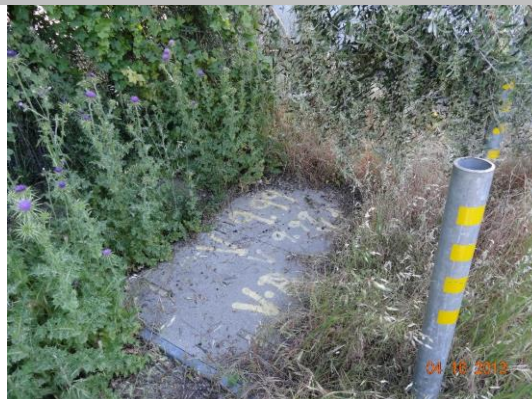
Photo 2 of 3 : UCIP\_FA\_2018\_39855\_69554.jpg

Service vault located on landward toe near gate access gate.

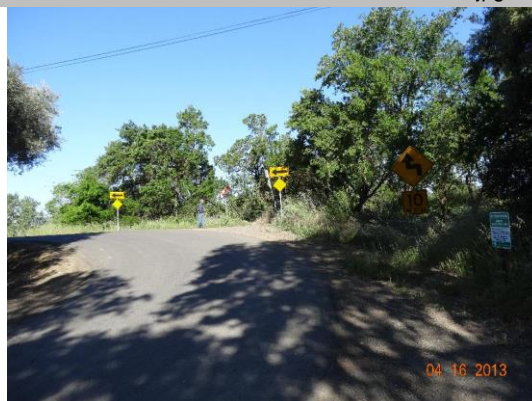
Photo 3 of 3 : UCIP\_FA\_2018\_39855\_69555.jpg

View of gas line marker located on levee crown.

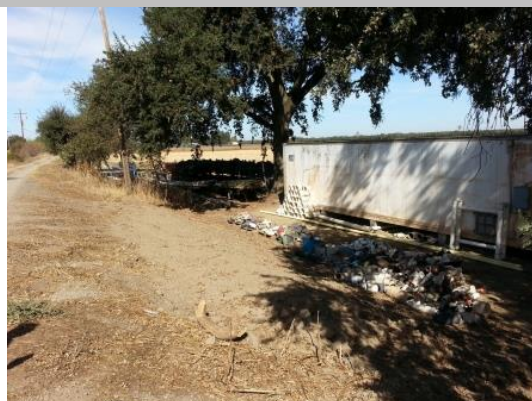
Photo 1 of 2 : FA\_2018\_NA0021\_351\_18\_20180904\_00012.jpg

LM Start	0.27	Rating **	M	Issue No.	18
LM End	0.27	Issue Type +	En	Location *	LS
Category	Earthen Levee			GPS Latitude/Longitude	
				Start	End
Item	Encroachments			38.722615 °	38.722615 °
				-121.806952 °	-121.806952 °
DWR ID	DWR_NA0021_01_s_2015_18				
Comment Code					
EQ : Equipment					
Inspector Comment

Updated picture of equipment near LS toe of the levee. Fall inspection 10/07/2016.

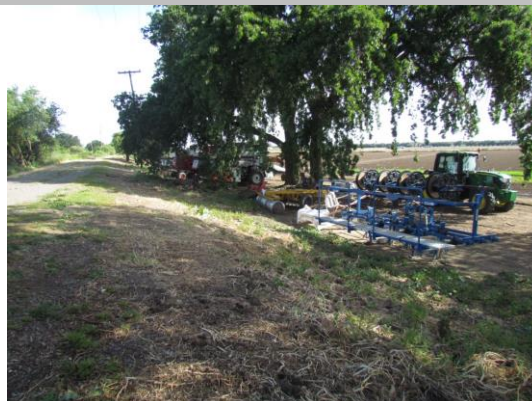
Photo 2 of 2 : FA\_2018\_NA0021\_351\_18\_20180904\_00013.jpg

View of equipment on the landward side of the levee looking downstream. Spring 2015.

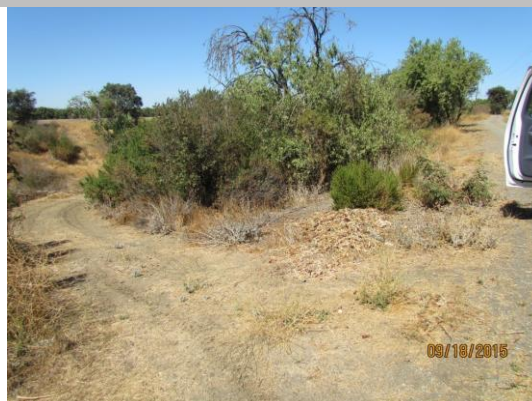
Photo 1 of 3 : FA\_2018\_NA0021\_351\_22\_20180904\_00014.jpg

LM Start	0.27	Rating **	M	Issue No.	22
LM End	0.27	Issue Type +	Ma	Location *	WS
Category	Earthen Levee			GPS Latitude/Longitude	
				Start	End
Item	Slope Stability			38.722620 °	38.722620 °
				-121.806958 °	-121.806958 °
DWR ID	DWR_NA0021_01_f_2015_22				
Comment Code					
S3 : Repair the levee slope damaged by vehicle traffic and prevent access where possible.					
Inspector Comment					
Unauthorized vehicle ramp by owner.

Perspective view of the trail on the waterward side of the levee looking downstream. Fall 2015.

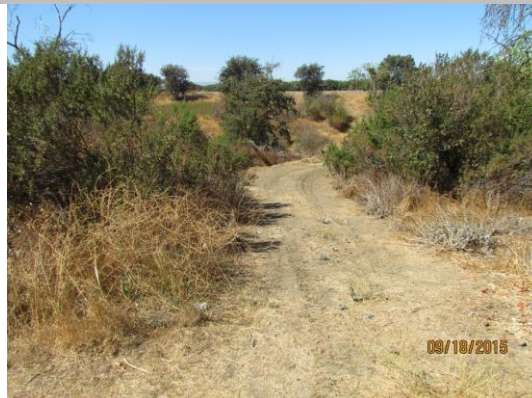
Photo 2 of 3 : FA\_2018\_NA0021\_351\_22\_20180904\_00015.jpg

View of the trail on the waterward side of the levee. Fall 2015.

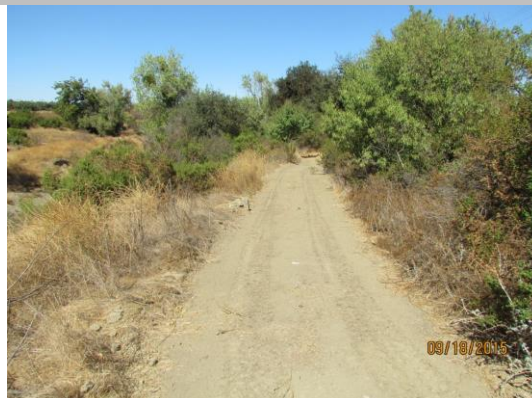
Photo 3 of 3 : FA\_2018\_NA0021\_351\_22\_20180904\_00016.jpg

The trail seems to be an access point that leads down to Cache Creek. Fall 2015.

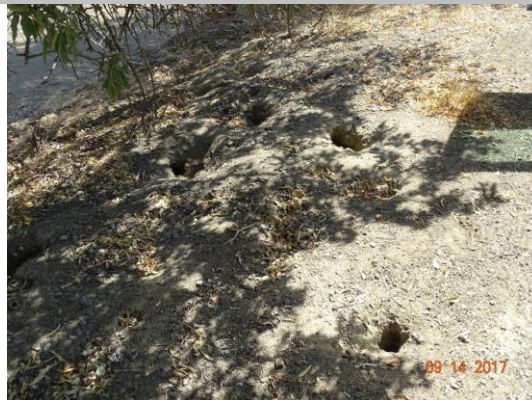
Photo 1 of 1 : FA\_2018\_NA0021\_351\_3\_20180904\_00001.jpg

LM Start	<b>0.45</b>	Rating **	M	Issue No.	<b>3</b>							
LM End	<b>0.45</b>	Issue Type +	Ma	Location *	LS							
Category	Earthen Levee		GPS Latitude/Longitude									
			Start	End								
Item	Animal Control		38.725115°	38.725115°								
			-121.806527°	-121.806527°								
DWR ID	DWR_NA0021_01_f_2017_3											
Comment Code												
A3 : No rodents visible, but rodent burrows visible; need to backfill and compact or grout burrows.												
Inspector Comment

Rodent holes on landward hinge point. Fall 2017.
